National Transportation Safety Board

Pipeline Accident Brief

Third-party Damage by Sure Shot Communications to Ameren Natural Gas Distribution System Canton, Illinois

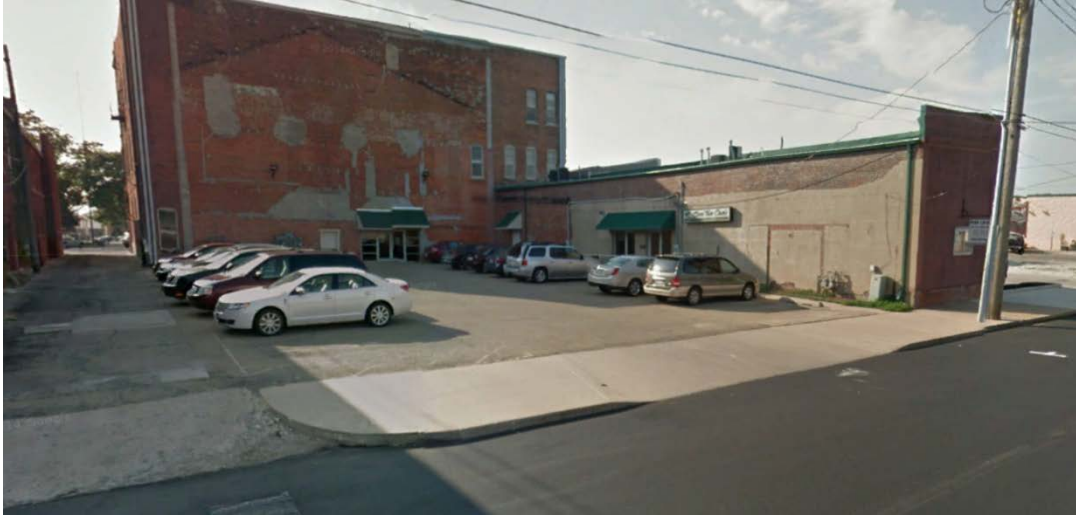
Figure 1. A Google Earth image of the back of the Opera House Professional Center and the two-level Opera House Annex prior to the accident.
